Customer: ECLO LDA

FAR No.: 40045571

FAILURE ANALYSIS REPORT DEVICE TYPE: DS1921G-F5#

DATE: January 9, 2013

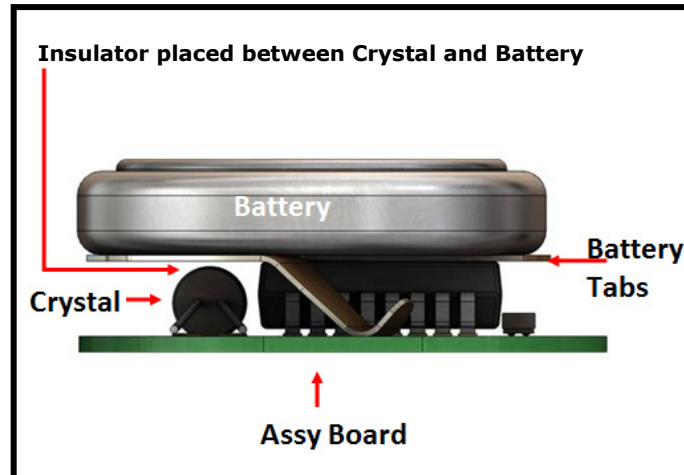
A corrective action was already implemented on DS1921 devices by adding an insulator in a form of Kapton tape in between the crystal and battery tab to prevent crystal to battery short. The units were not included in the corrective action since this was implemented on August 2012 and the units were assembled last week of December 2011. *Below is the DS1921 assembly photo.*

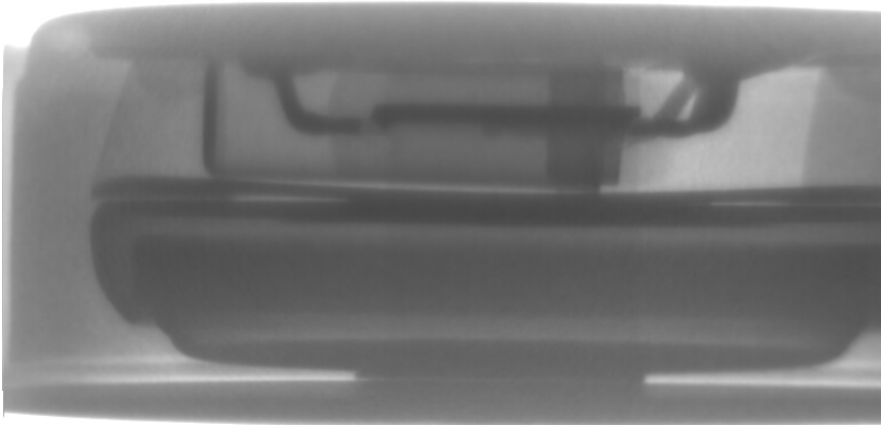
Figure 1.

SN 1 to 3: X-ray inspection revealed crystal barrel to positive battery terminal short. *Refer to figures 1 and 2.*

SN 1:

X-ray photo showing the crystal barrel shorted to the connection of positive terminal of the battery.

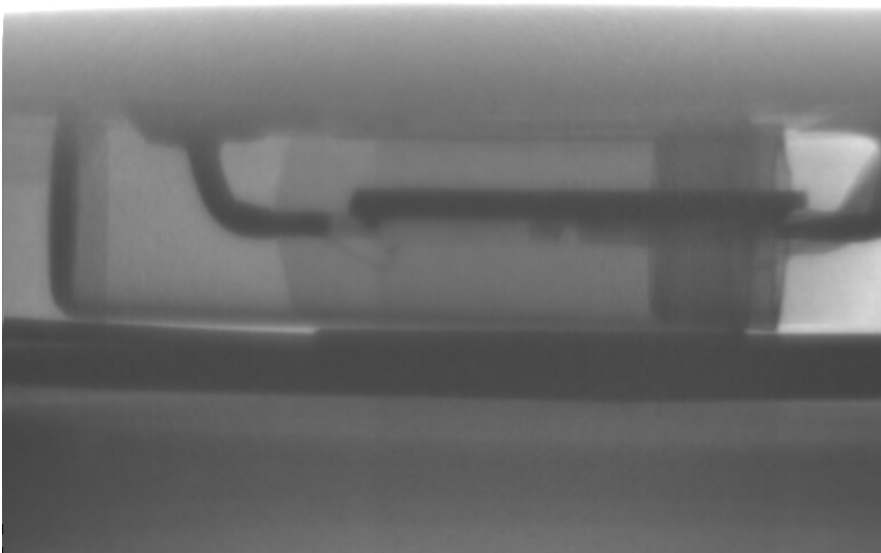
Figure 2.

SN 2:

X-ray photo showing the crystal barrel shorted to the connection of positive terminal of the battery.

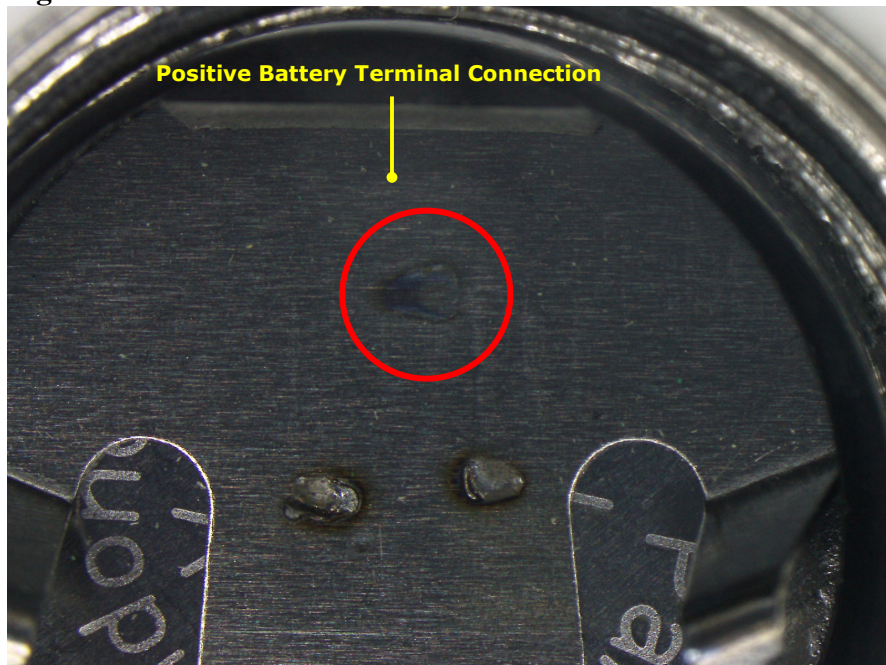
Figure 3.

SN 1 to 3: Units were decanned for internal visual inspection. Internal visual inspection revealed indication of crystal barrel to positive battery terminal short. Discolored crystal could also be observed during internal visual inspection. Battery voltages of the units were found to be depleted. *Refer to figures 3 to 5.*

SN 1:
Magnification: 12X

Optical photo showing the indication of crystal barrel to positive terminal of the battery short after decanning.

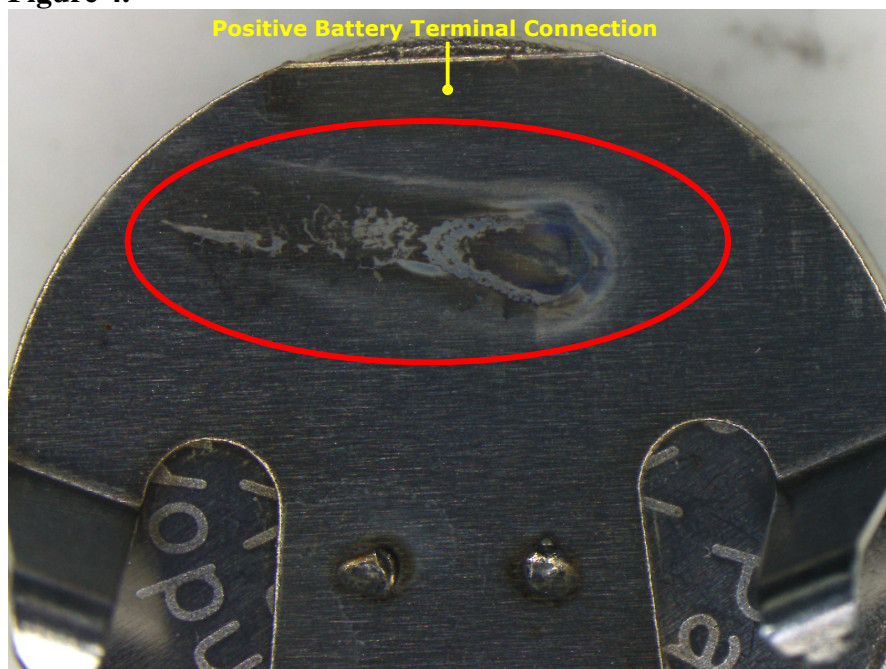
Figure 4.

SN 2:
Magnification: 12X

Optical photo showing the indication of crystal barrel to positive terminal of the battery short after decanning.

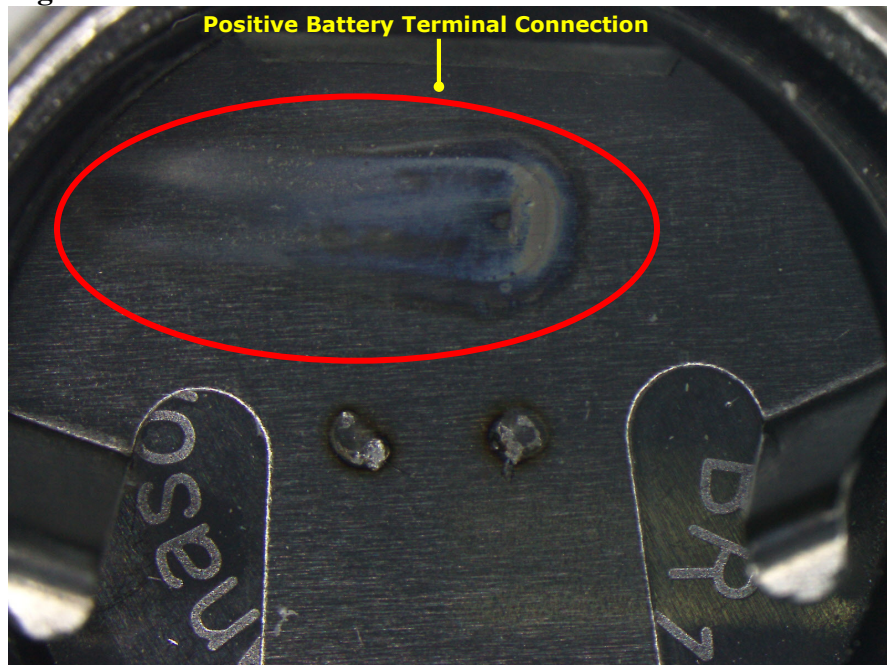
Figure 5.

SN 3:
Magnification: 12X

Optical photo showing the indication of crystal barrel to positive terminal of the battery short after decanning.

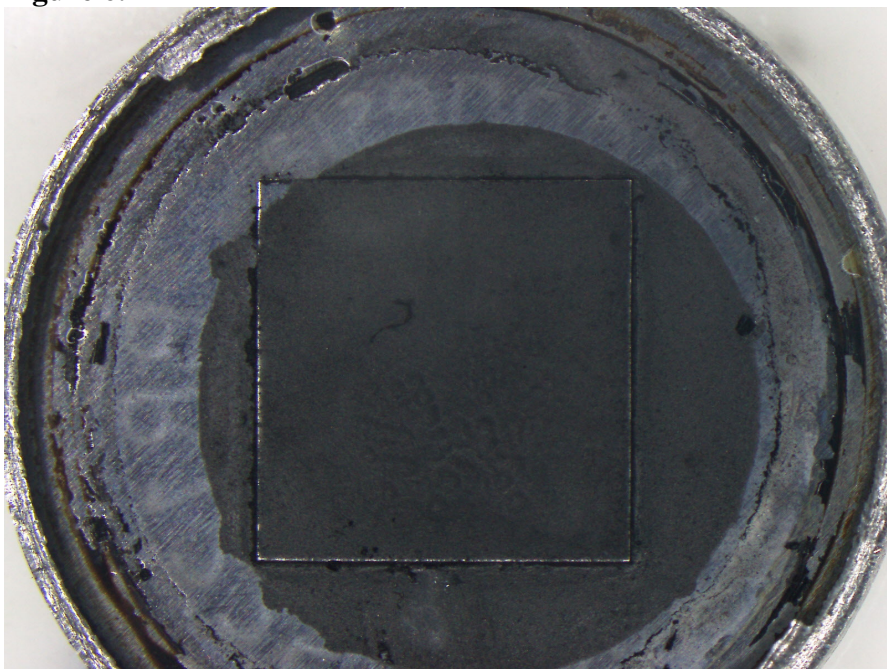
Figure 6.

SN 1 and 4: Battery of the units was decanned to expose the internal structure of the battery. Internal visual inspection on the batteries revealed dry cathode pill, no lithium on battery can, and dark separator which indicate heavy load discharge. *Refer to figures 6 to 14.*

SN 1:
Magnification: 12X

Optical photo showing no lithium on the battery can.

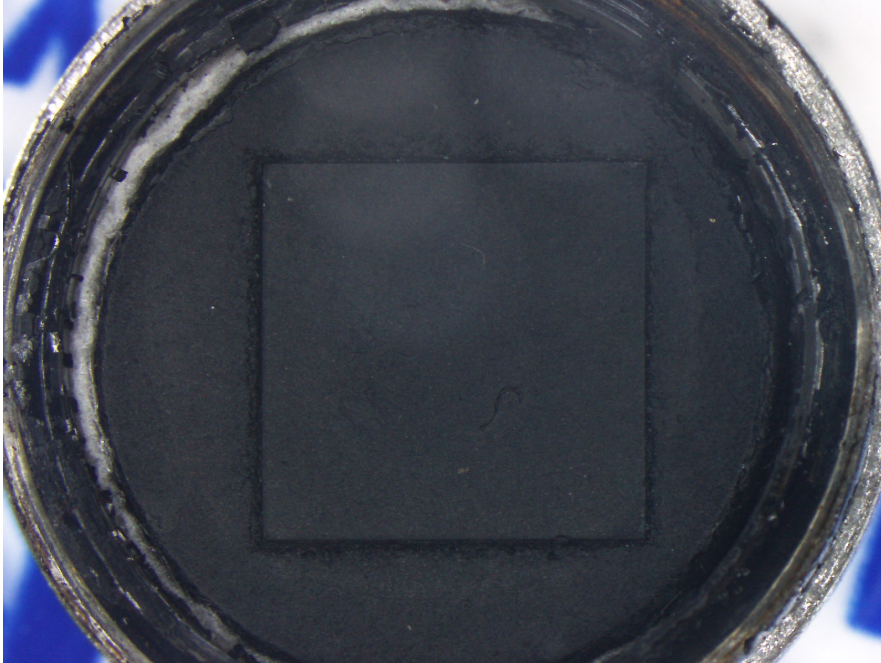
Figure 7.

SN 1:
Magnification: 12X

Optical photo showing dry cathode pill.

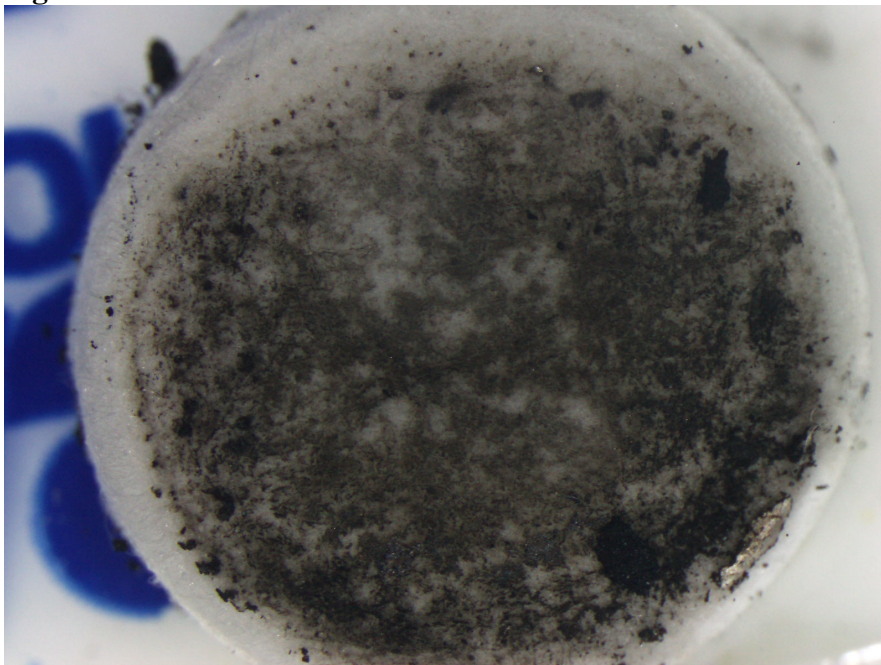
Figure 8.

SN 1:
Magnification: 12X

Optical photo showing dark separator indicating heavy load discharge.

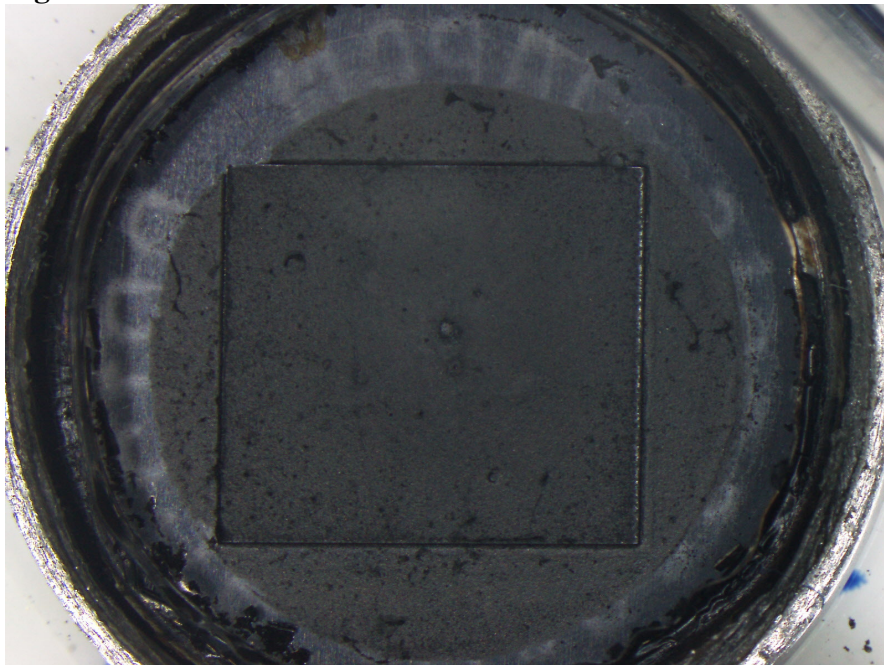
Figure 9.

SN 4:
Magnification: 12X

Optical photo showing no lithium
on the battery can.

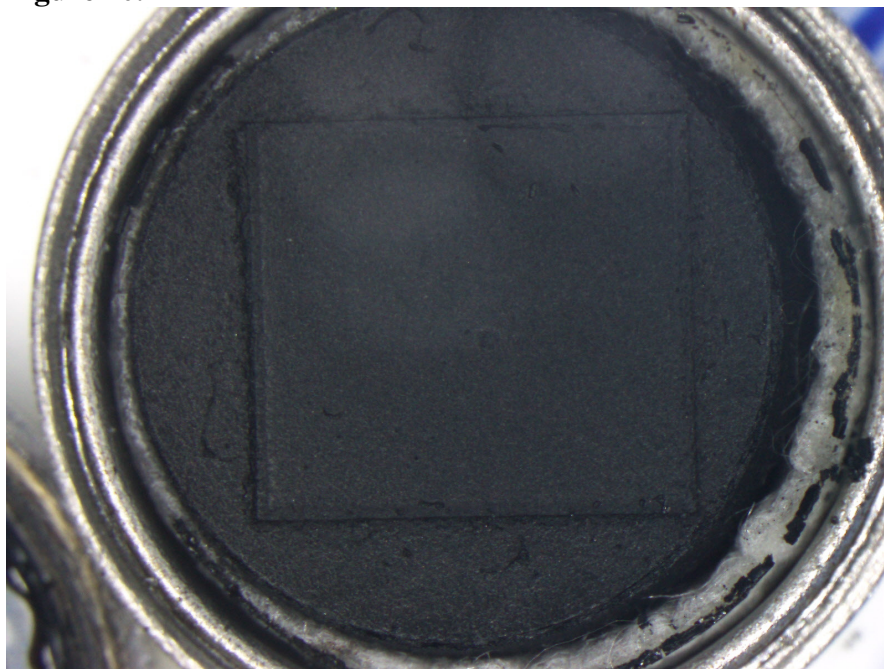
Figure 10.

SN 4:
Magnification: 12X

Optical photo showing dry cathode
pill.

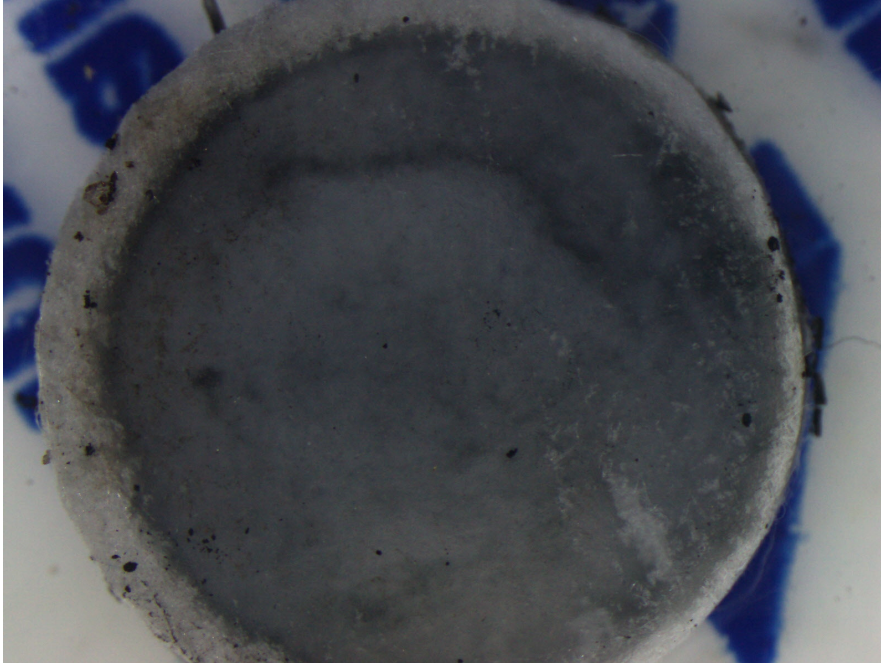
Figure 11.

SN 4:
Magnification: 12X

Optical photo showing dark separator indicating heavy load discharge.

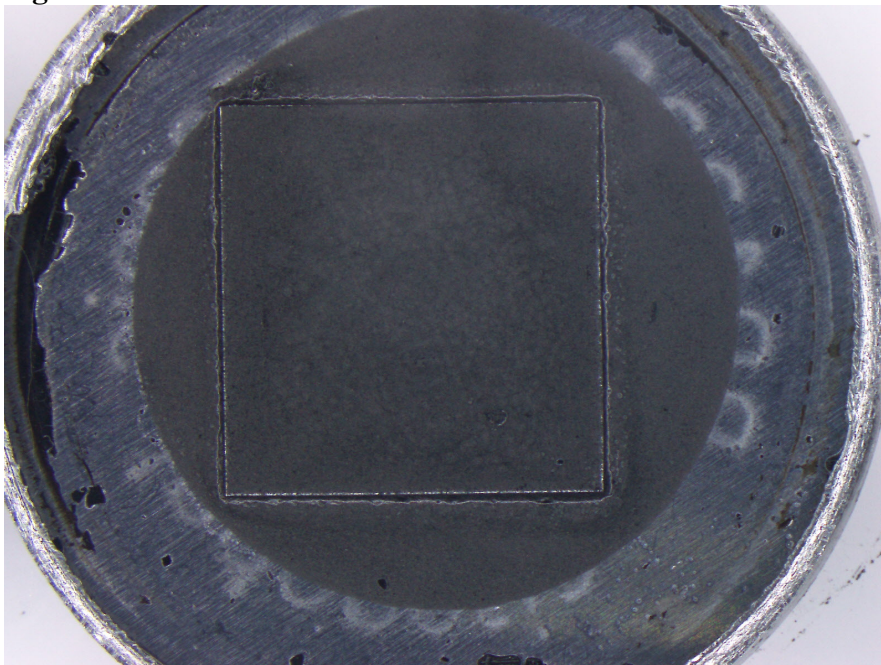
Figure 12.

KGU:
Magnification: 12X

Optical photo showing lithium present on the battery can.

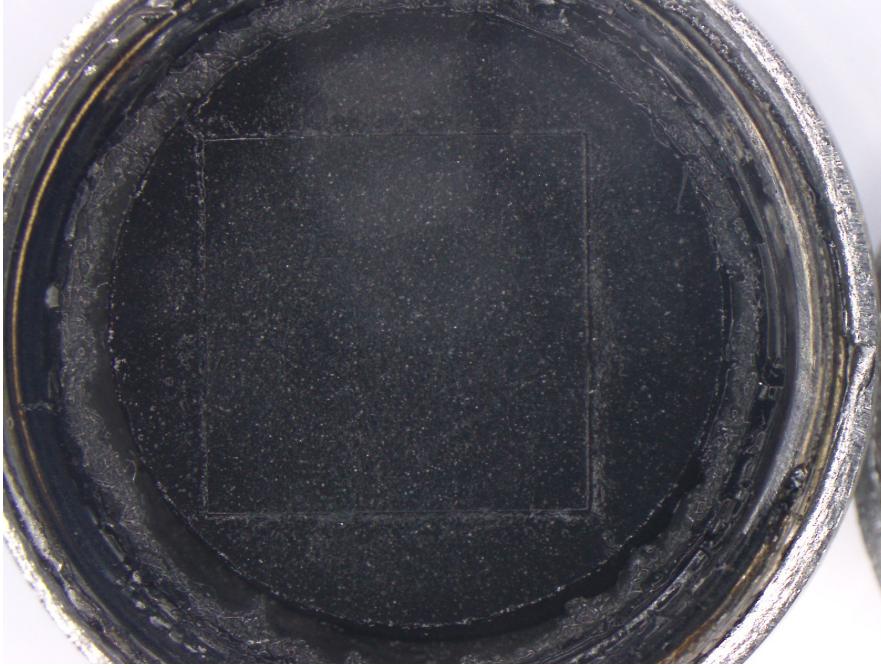
Figure 13.

KGU:
Magnification: 12X

Optical photo showing moist
cathode pill.

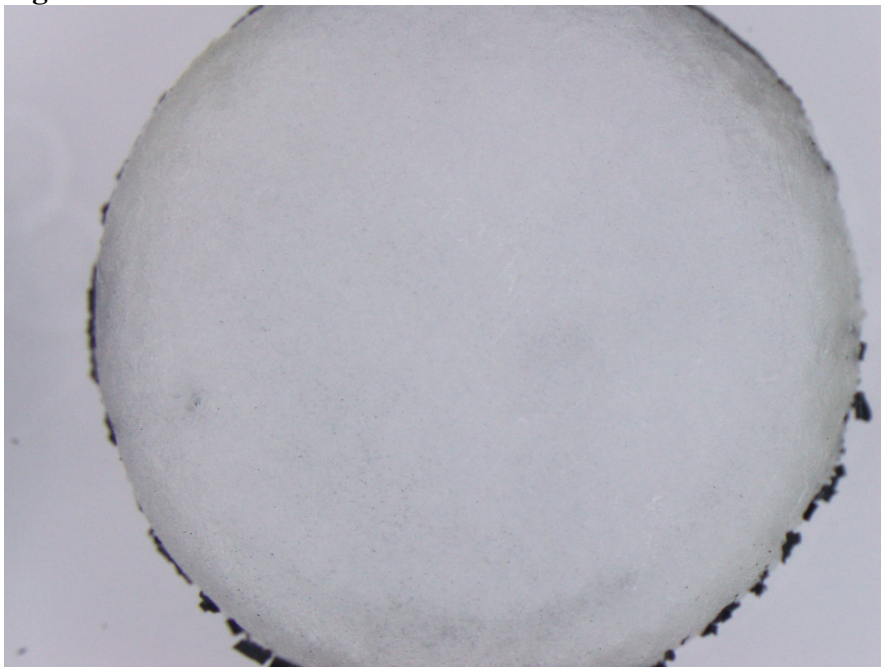
Figure 14.

KGU:
Magnification: 12X

Optical photo showing white
separator of a known good unit
(KGU).
